**Final Postflight Hardware Evaluation Report  
RSRM-32 (STS-57)**

**November 1993**

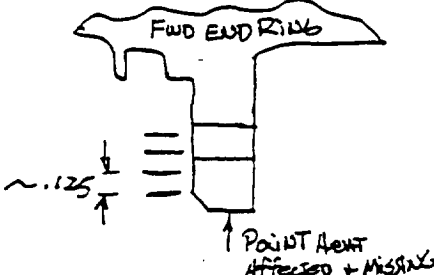
HARDNESS TESTING OF JOINT METAL SURFACES IN GAS PATH REGIONS:

<p>FWD END RING</p> <p>~.125</p> <p>POINT AREA AFFECTED + MISSING</p>	132.5°	.125	45
		.250	44
		.375	44
		<del>.500</del>	
	318°	.125	45
		.250	44

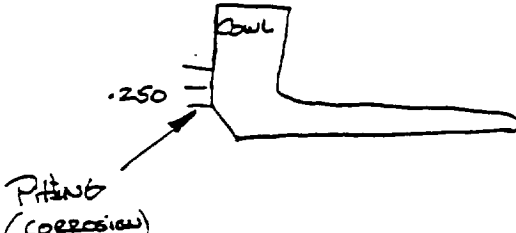
<p>COWL</p> <p>.250</p> <p>PITTING (CORROSION)</p>	132.5°	.250	88
		.500	88
	318°	.250	88
		.500	88

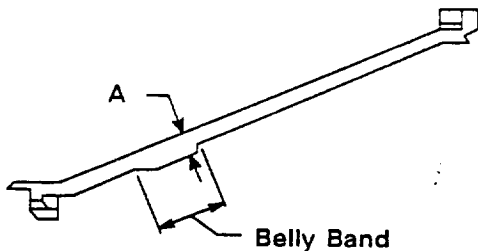
**Flexible Bearing Protector Gas Impingement Area Thickness Measurements (see figure):**

Degree Location	Thickness Measurement A* (inches)	Degree Location	Thickness Measurement A* (inches)	Degree Location	Thickness Measurement A* (inches)
0	.765	120	.738	240	.723
10	.715	130	.746	250	.725
20	.730	140	.735	260	.715
30	.735	150	.730	270	.701
40	.740	160	.720	280	.718
50	.705	170	.715	290	.725
60	.750	180	.721	300	.715
70	.740	190	.715	310	.715
80	.732	200	.710	320	.720
90	.730	210	.728	330	.735
100	.728	220	.730	340	.720
110	.735	230	.720	350	.705

\* "A" is the minimum thickness of the bearing protector belly band in-line with the cowl vent holes. It corresponds to the deepest gas impingement location.

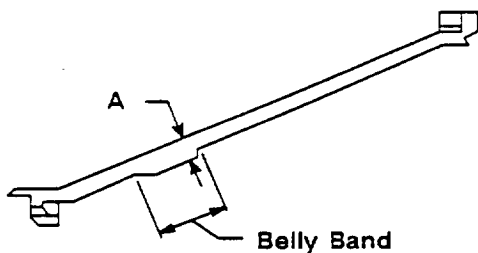
Flexible Bearing Protector Gas Impingement Area Thickness Measurements (see figure):

Degree Location	Thickness Measurement A* (inches)	Degree Location	Thickness Measurement A* (inches)	Degree Location	Thickness Measurement A* (inches)
0	.718	120	.728	240	.731
10	.722	130	.715	250	.654
20	.727	140	.718	260	.733
30	.730	150	.725	270	.725
40	.732	160	.721	280	.736
50	.733	170	.723	290	.725
60	.735	180	.726	300	.715
70	.733	190	.728	310	.69
80	.735	200	.736	320	.71
90	.725	210	.675	330	.72
100	.695	220	.736	340	.715
110	.763	230	.734	350	.722

\* "A" is the minimum thickness of the bearing protector belly band in-line with the cowl vent holes. It corresponds to the deepest gas impingement location.
